# Simcom A7600c1 LTE Module for Intelligent and Realtime Precision Maintenance Scheduler on a Volvo In-Line D16C610 Engine

**Abstract**—The intensive usage of the engine requires a real time and intelligent approach on how or when to perform a daily maintenance. Volvo in-line D16C610 engine is specifically installed on a FH16 prime mover truck head dragging a single or double trailer (vessel) weigh about 136.4 – 140 metric ton for each vessel. Unfortunately, the parameter used for the maintenance schedule is depend only on hour-meter (HM) which shows running hours of the engine regardless the speed, load, or temperature of oil. This faulty parameter therefore made the maintenance schedule inefficient and faulty. A Simcom A7600c1 LTE Module is installed on an ECU as transmitter to feed the data to the central maintenance planner. Based on the data collected by the system such as engine oil temperature sensor (EOTS) and Crankshaft Position Sensor (CPS). The data for precision maintenance schedule based on real time condition of the engine is recorded via Blynk cloud IoT server and exported to a csv file for further process. The device prototype has been installed and tried in a real

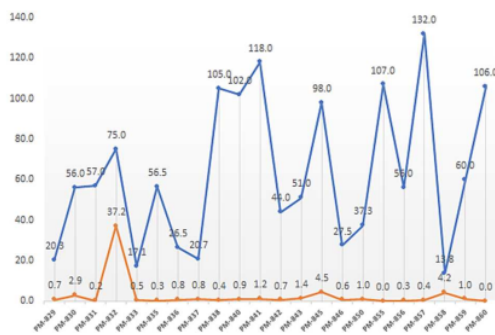
Fig. 2. Graph Showing MTTR (orange line) and MTBF (blue line) of Volvo machine in week 49, year 2021

The ideal value of MTBF is in match with engine lifetime which is 22000 hours. The down time parameter is calculated from DMBD data specifically on service start hour column and service end hour column. The up-time parameter is taken from standby hour of the unit. MTTR and MTBF of Volvo unit number PM-829 shown in Fig. 2, on the left is calculated in a week period from 8 December 2021 – 14 December 2021 taken from [2]. The graph shows that each machine unit has different parameter and value. It could be concluded that the lowest MTBF is PM-829 with value 20.3 hours, which means the failure occurs every 20.3 hour in a week period. The value for MTTR is 0.7 hour which means it only need 0.7 hour for each repair in every failure for this week.

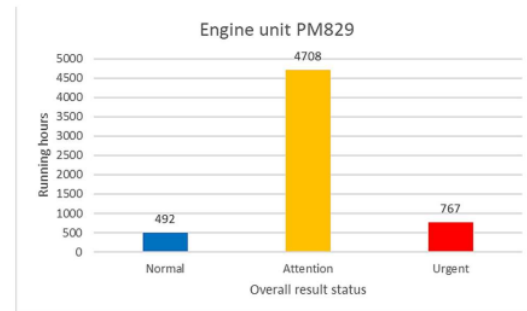
Fig.3. Graph of engine unit PM-829 running hour spent in a normal/attention/urgent state from engine oil analysis using ASTM D5185-18 by PT United Tractor

Data of oil analysis in [8] and [9] show that in a range of a year (January 2021 – December 2021) presented in Fig. 3, the engine oil unit PM-829 has spent 96.66% of its total running hours in “attention” status, 3.33% in urgent status. This means in a year, the engine is in danger, abnormal state for about 96% of its running hours and only 4% in healthy condition. If condition like this continues for another year, the engine will not be able to achieve its normal lifetime.

Data of oil analysis in [8] and [9] show that in a period of a month in January 2022 in Fig. 3, the engine oil unit PM-829 has spent 100% of its total running hours in "normal" status. Compare to year 2021, the engine oil analysis results healthier condition.

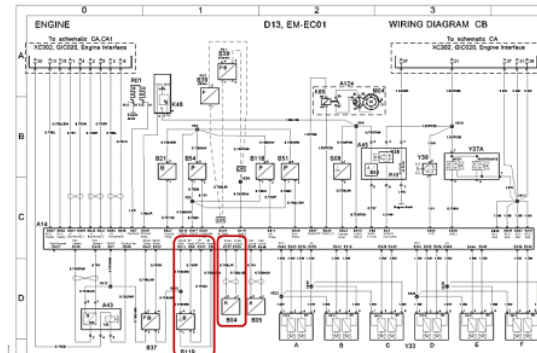
Sensor circuitry on Volvo D16C610 is shown in Fig 5. The schematic pin position for Crankshaft Position Sensor (CPS) is labeled B04 pin 1 and pin 2 is attached to ECU pin EA37 and EA38 respectively. The Engine Oil Temperature Sensor (EOTS) is labeled B119 pin 3 is attached to ECU pin EA31.

Fig. 5. Schematic shows wiring diagram of Volvo D16C610 Engine sensor circuit page 19 section CB, EM-EC01

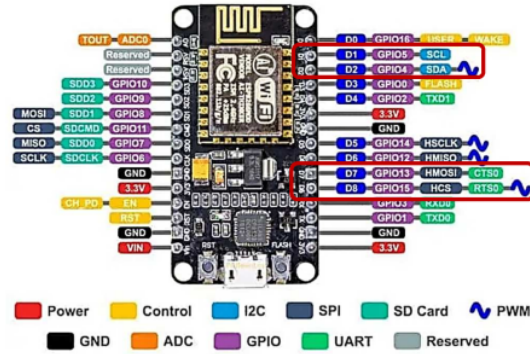
NodeMCU is an open source Lua based firmware for the ESP8266 WiFi SOC from Espressif and uses an on-module flash-based SPIFFS file system. NodeMCU is implemented in C and is layered on the Espressif NON-OS SDK [11]. The controller has 11 digital IO pins, and 1 analog input pin. Other controller function is shown on Fig 6.

Fig. 6. NodeMCU Lua Esp8266 Pinout Schematic Diagram

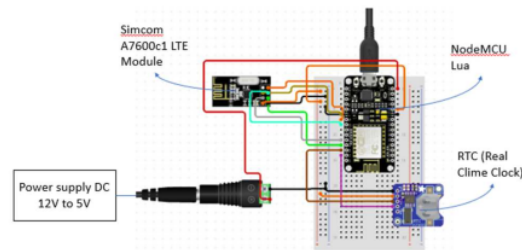
The system module is powered using DC to DC converter to convert 12v truck head accumulator to 3.3v shown in Fig 8. RTC or real time clock is attached to D2 and D1 NodeMCU pins for serial communication. The RTC is used to timing the data transmission to Blynk cloud. Simcom A7600c1 LTE Module is connected to D6 and D7 (MOSI and MISO) NodeMCU pins respectively for internet connection via Telkomsel cellular networks. Further pin position can be observed in Fig 6. in red rectangular area. The network card is selected due to its best signal available on the site based on [13].

Fig. 8. Block diagram showing wiring connection of the system

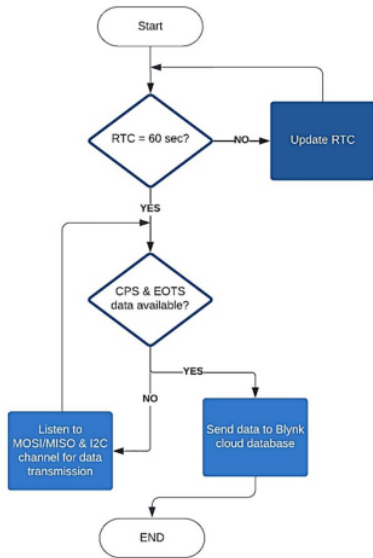
The controller is programmed by C language to perform communication MOSI/MISO and I2C function using algorithm presented in Fig 9.

Fig. 9. Flowchart showing algorithm programmed to NodeMCU

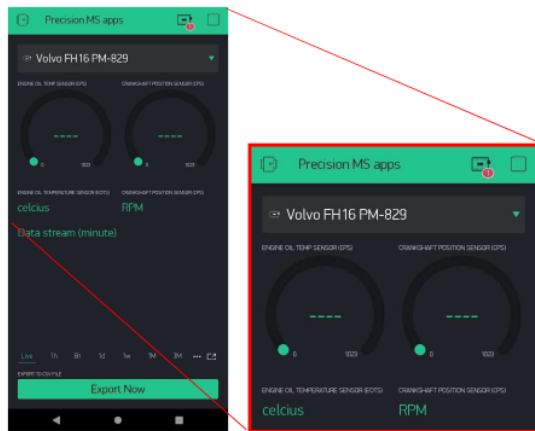
Blynk apps is an IoT interface that has cloud database service. The interface is used to download the data collected by NodeMCU. [14], [12], [15], [16], [17], [18] and [19] indicated that Blynk has ability to stored frequent data send to its cloud server and export them to a csv file type for further process. The design interface of the app named Precision MS apps is shown in Fig 10.

Fig. 10. Interface design of Blynk app developed using Blynk Development Software

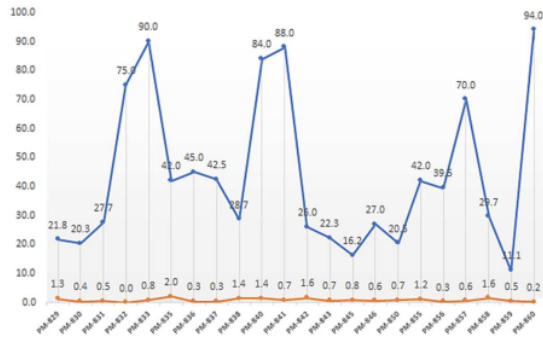
MTTR and MTBF of Volvo unit number PM-829 shown in Fig. 11. on the left. The parameter is calculated in a week period from 9 January 2021 – 16 January 2022 taken from [20]. The graph shows that the lowest MTBF is PM-829 with value 21.8 hours, which means the failure occurs every 21.8 hour in a week period. The value for MTTR is 1.3 hour which means it needs 1.3 hour for each repair in every failure for this week. Compare to the parameter before the implementation, value for MTBF is getting better about 1.8 hour and worse in MTTR about 0.6 hour

Fig. 11. Graph Showing MTTR (orange line) and MTBF (blue line) of Volvo machine after the implementation of real time precision maintenance scheduler
